Manhole Inspection Summary

Manhole # S45C__021MH

Insp Date: **8/19/08 9:16 AM**

Location Address: **Fayette**

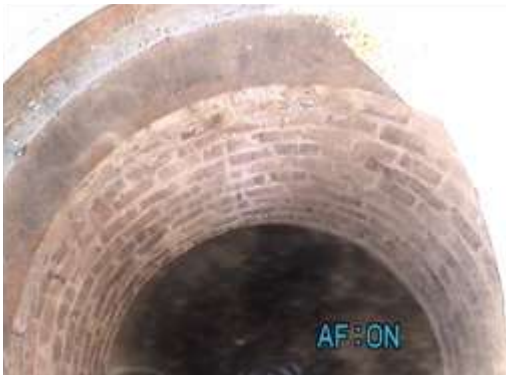
Defect 2

Infiltration

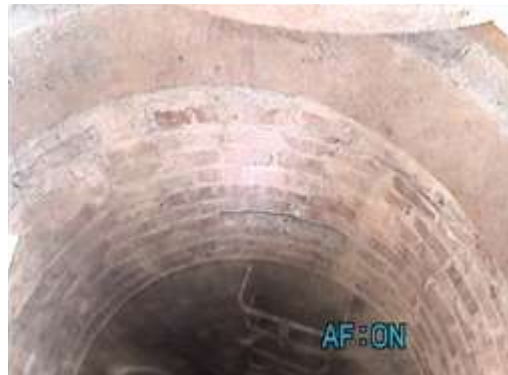
Defect 1

Frame leaks

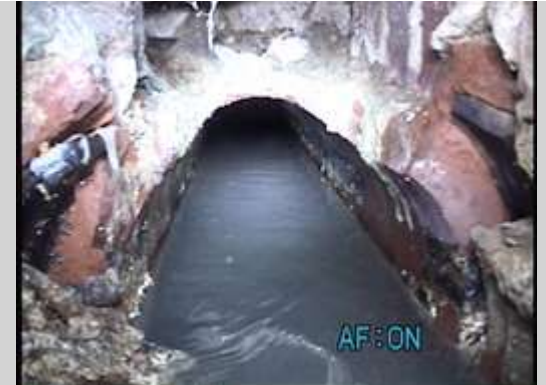
12 O'Clock Outflow

8 in. Circular Gravity Sewer
Pipe Out @ 12 O'Clock

Pipe Height: **8.4** (in.) Rod and Bar (Angled)
Pipe Material: **Clay** ☐ Pipe Lined
Invert Depth: **10.70** (ft.) Flow Characteristics: **Fast**
Deposits: ☒ None ☐ Mud ☐ Sludge ☐ Debris ☐ Grease
Silt Depth: (in.) Deposits Extent:
Infiltration: **None** Pipe Seal Cond: **Sound**

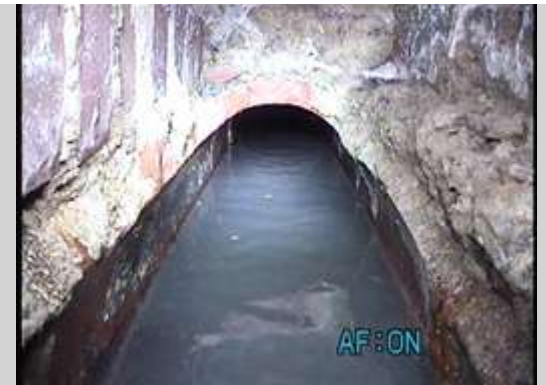
6 O'Clock Inflow

8 in. Circular Gravity Sewer
Pipe In @ 6 O'Clock

Pipe Height: **8.4** (in.) Rod and Bar (Angled)
Pipe Material: **Clay** ☐ Pipe Lined
Invert Depth: **10.65** (ft.) Flow Characteristics: **Fast**
Deposits: ☒ None ☐ Mud ☐ Sludge ☐ Debris ☐ Grease
Silt Depth: (in.) Deposits Extent:
Infiltration: **None** Pipe Seal Cond: **Sound**

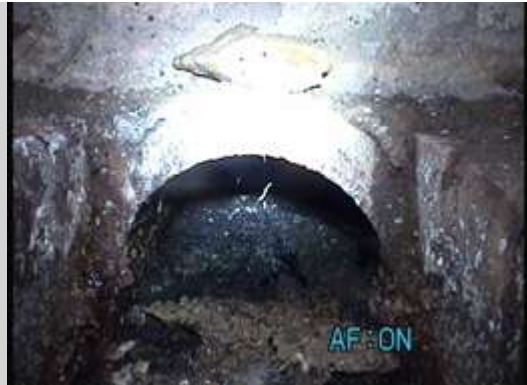
9 O'Clock Inflow

Pipe In @ 9 O'Clock

Infiltration: **None** Pipe Seal Cond: **Sound**
